Manhole Inspection Summary

Manhole # S07AA2003MH

Location Address: **5901 CROSS COUNTRY BLVD** Cross Street: **BERKELEY AVE**

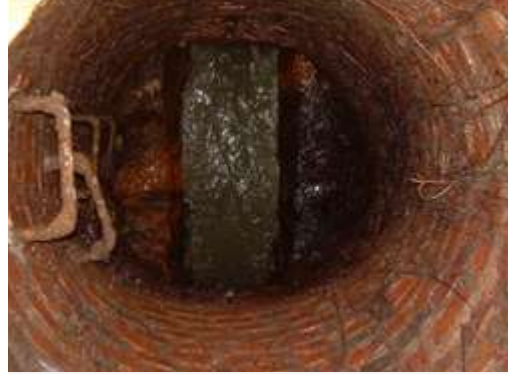
Top View

Corroded steps. Evidence of surcharge - Bench debris.

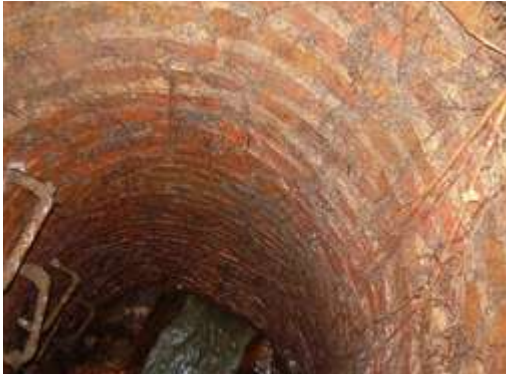
Defect

Adjustment, Corbel and Barrel root intrusion and infiltration - other side.

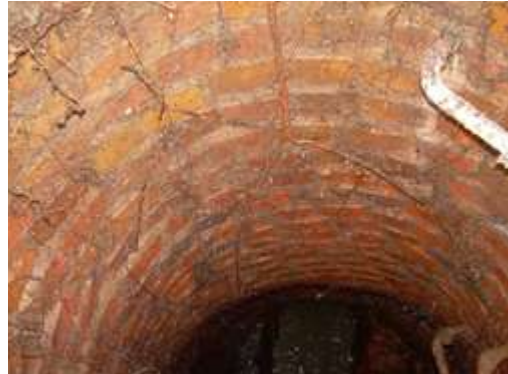
Defect

Adjustment, Corbel and Barrel root intrusion and infiltration.

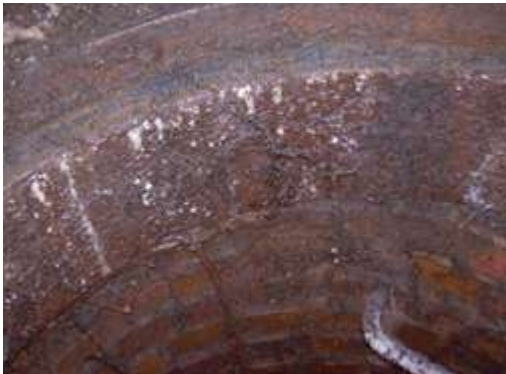
Defect

Frame leaks. Adjustment deterioration, root intrusion and infiltration.

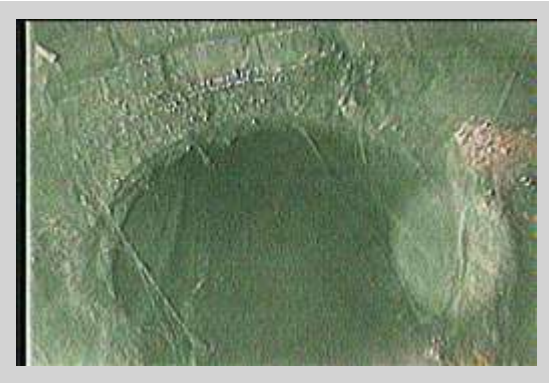
24 in. Circular Gravity Sewer Pipe Out @ 12 O'Clock

Infiltration: **None** Pipe Seal Cond: **Roots**

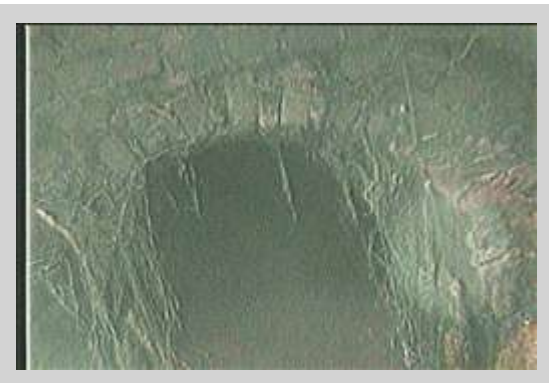
24 in. Circular Gravity Sewer Pipe In @ 6 O'Clock

Barrel deterioration, root intrusion and infiltration. Channel root intrusion.

Infiltration: **Evidence** Pipe Seal Cond: **Broken**
